DAMAGE DUE TO STRANDING

Vessel name:	Melody

Registered port:	St John, USVI	
Assured:	Martin Andersson	
Hull identification number:	CAT47120B000	
Vessel description:	2000 model Catana 471 FRP sloop rigged catamaran with twin auxiliary diesel engines. Approximate dimensions 47'L x 25'B x 5'D (measurements not taken).	
Policy #:	CSRYP/172119	
Status:	Recommended to Underwriters as a Constructive Total Loss pending coverage.

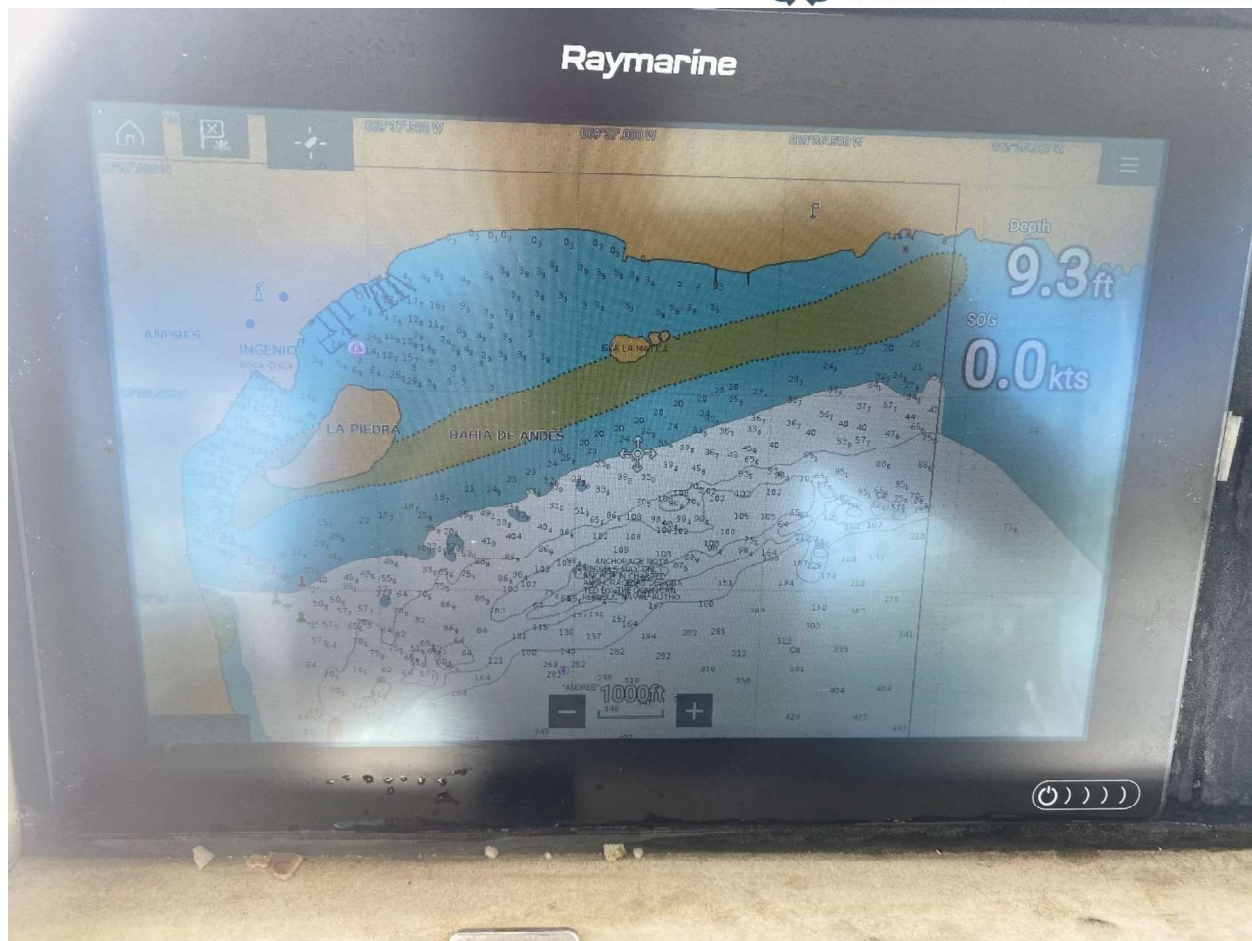
>2 year old chart data taken from our company vessel.

The breakwater is unlit at night.

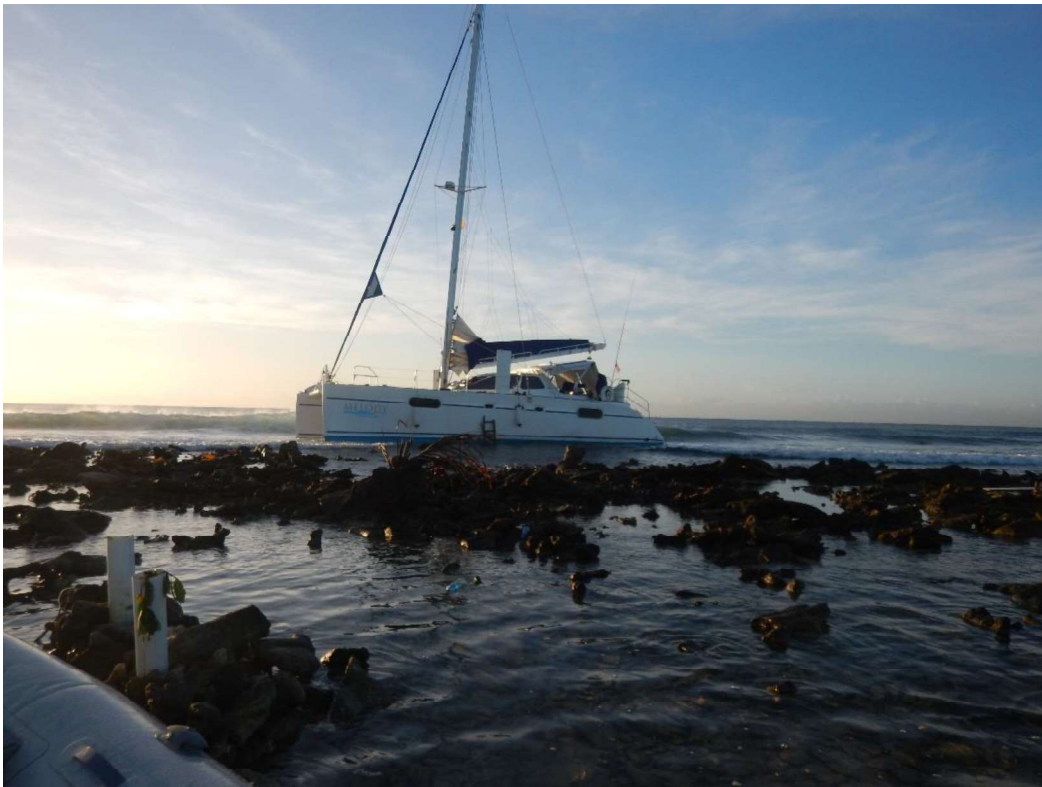
Vessel in current position
